## BULLETIN

### Observations regarding THANNER DK2010/2011 HYDROSTATIC RELEASE UNIT

date. 13.05.2016

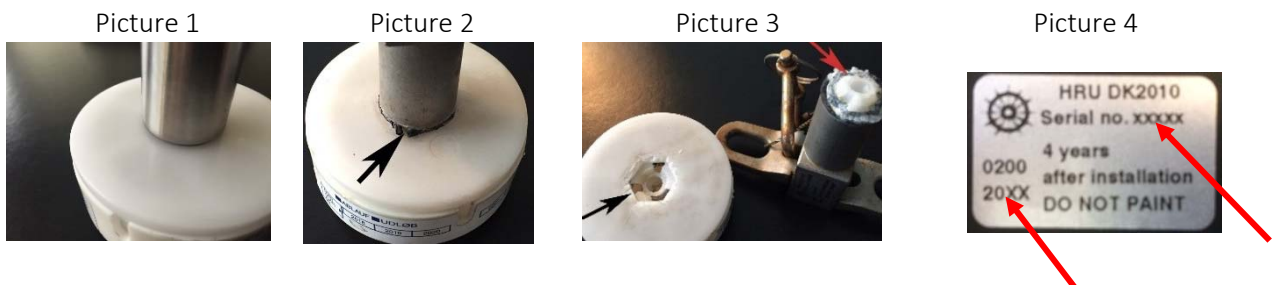
A possible defect O-ring in the sealing of the stainless steel body and the composite release top, might fail, and can over time lead to failure of the Hydrostatic Release Unit DK2010/2011.

If the “defective” O-ring fails, it allows water into the parts, causing corrosion leading to the composite part to detach from the HRU.

If the O-ring is defect, the HRU will after 2-3 years in service depart from the body.

**Picture 1:** O-ring between body and composite part well protected.

**Picture 2:** O-ring starts to crackle, brakes and allows moisture between composite part and body.  
(duration 2-3 years)

**Picture 3:** The corrosion makes the composite part to brake of.

**Picture 4:** Serial No xxxx, year of manufacture and picture shall be enclosed by any enquiry.

Please check the serial numbers, inspect the HRU on board and compare your Hydrostatic Release Units with the pictures 1 - 4 to see if your device needs replacement. If so, please contact the manufacturer THANNER A/S or your supplier for more information and to agree replacement.

If the HRU shall be replaced, please forward serial No and picture of the HRU to THANNER A/S.
